**Flood Control Project Maintenance
Levee Inspections**

Maintenance Issue Types Only, Levee Inspection Report By Mile - Fall 2016

Sacramento Maintenance Yard West Levee Yolo Bypass

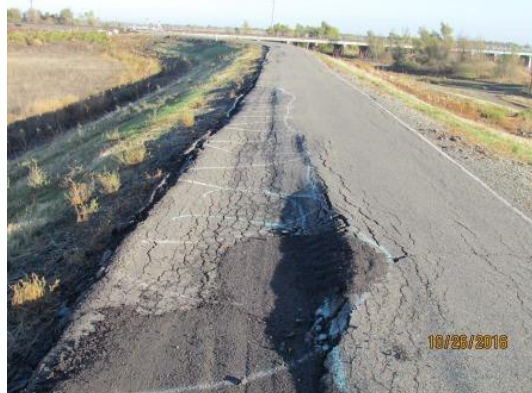
Photo 1 of 1 : FA_2016_ST0011_294_12_20161027_00009.jpg

| Item | Crown Surface / Depressions / Rutting | | | 38.564543 ° | 38.564403 ° |

Asphalt paved crown has depression at this site. Fall 2016.

| C2 : Repair depressions or ruts in the crown or slope. | | | | | |

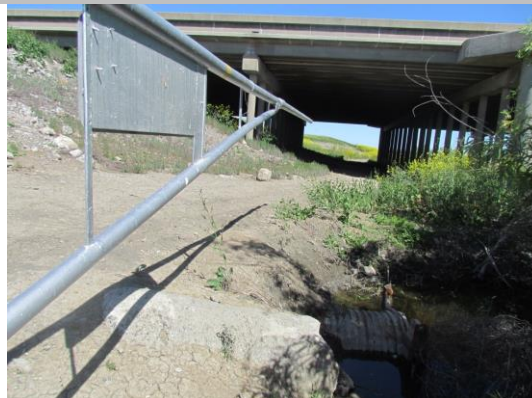
Photo 1 of 3 : FA_2016_ST0011_294_2_20160913_00001.jpg

| There seems to be obstructions that prevents the gate from fully closing. Remove debris from flap gate. | | | | | |

View of a perspective on the pipe looking upstream. Spring 2015.

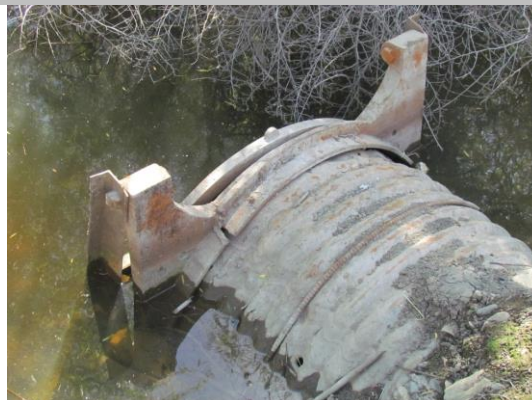
Photo 2 of 3 : FA_2016_ST0011_294_2_20160913_00002.jpg

View of the flap gate in the ditch on the water side of the levee. There seems to be debris preventing the flap gate from closing. Spring 2015.

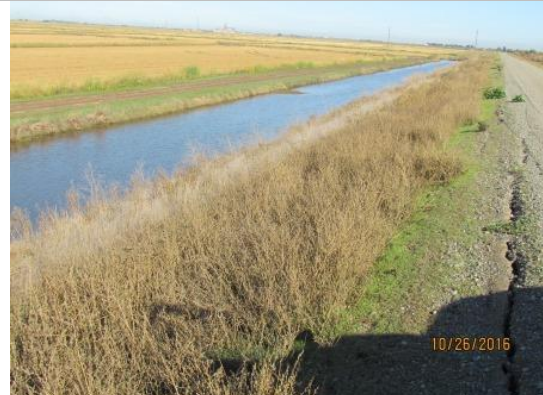
Photo 1 of 1 : FA_2016_ST0011_294_18_20161027_00015.jpg

View of vegetation on WS slope. Fall 2016.

| V2 : Remove the wild growth other than native grasses from the levee slopes. | | | | | |
